**ALBERTA BUILDING ENVELOPE
FAILURE ANALYSIS**

MUNICIPAL AFFAIRS
Innovative Housing Grants Program

June 1991

G. F. Johnson
Morrison Hershfield Limited

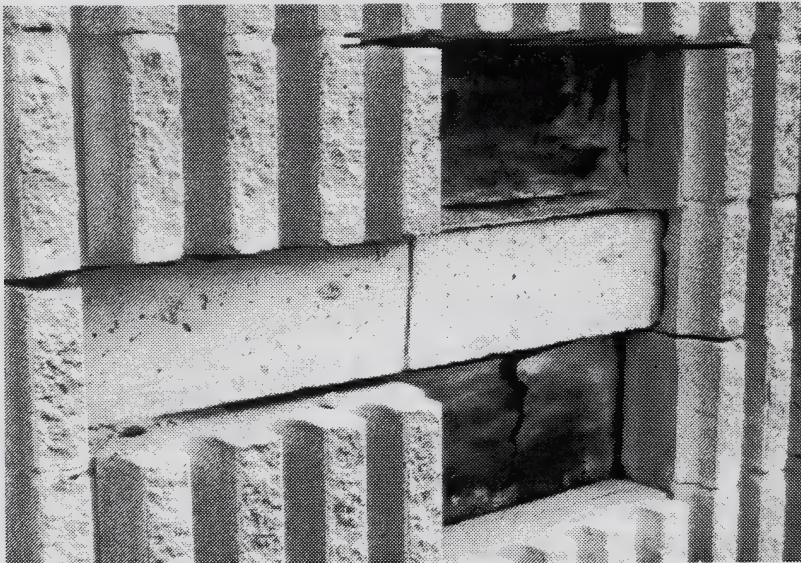
Block Veneer Photograph
Figure 7

Flashing stops short of exterior face of veneer,
no soft joint under veneer at support, thermal bridge at end of slab

The most common problem encountered was the lack of soft joints at the underside of the veneer support angles. This soft joint is required to accept the differential movement that occurs when the brick expands and the floor slabs deflect or the concrete frame shrinks as a result of creep. The photographs in Figures 7 and 8 are examples of typical problems

found. Figure 9 illustrates a suggested masonry shelf angle detail, including measures necessary to allow for creep and deflections. (See 4.4.12, Cost of Repair, for a discussion of these figures.)

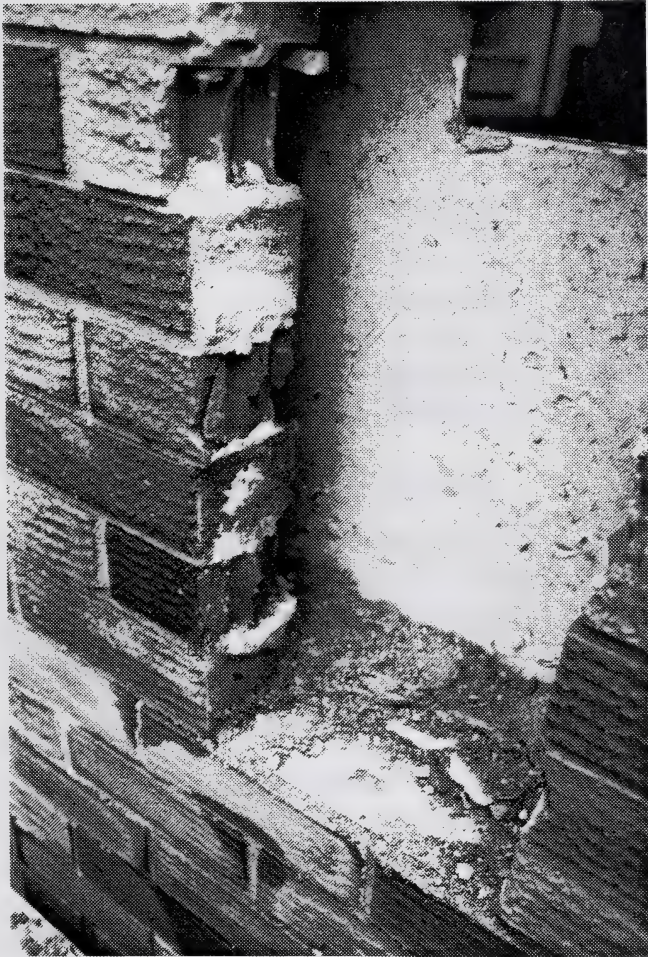
Brick Veneer Photograph
Figure 8

Mortar droppings behind veneer, flashing stops short of exterior face of veneer,
no soft joint under veneer at support

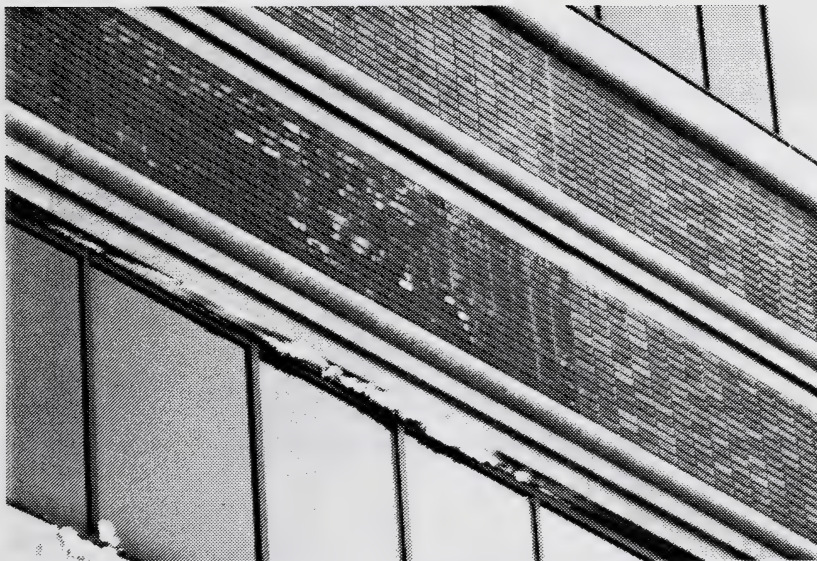
Consequences of Air Leakage
Figure 10

An example of the consequences of excessive air leakage is shown in Figure 10. This photo (not one of the surveyed buildings) shows moisture and ice buildup at the connection between the windows and precast wall panels, and efflorescence on the brick.

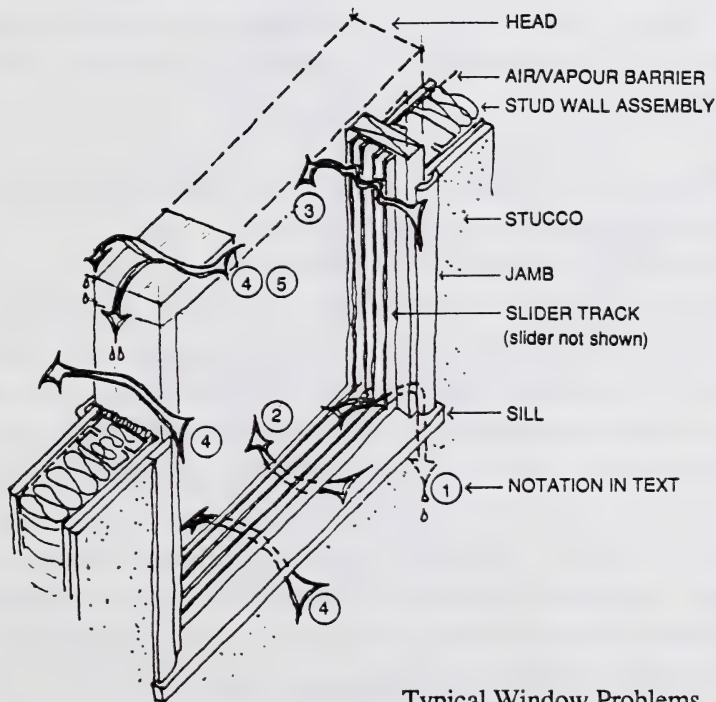
Typical Window Problems
Figure 11

Typical types of window problems identified in our survey are shown schematically in Figure 11. Because it has the worst record of performance, a horizontal slider in a single wythe stud wall is depicted. Other window and wall assembly combinations suffer similar problems but usually not to the same degree.

Location 1 illustrates water infiltration at the sill/jamb connection, by far the most serious and common. The tracks become filled with water due to plugged or nonexistent drain holes and the poor seal at the junction of the sill and jamb allows the water to enter the assembly. This problem is usually due to a combination of low quality windows and poor maintenance.

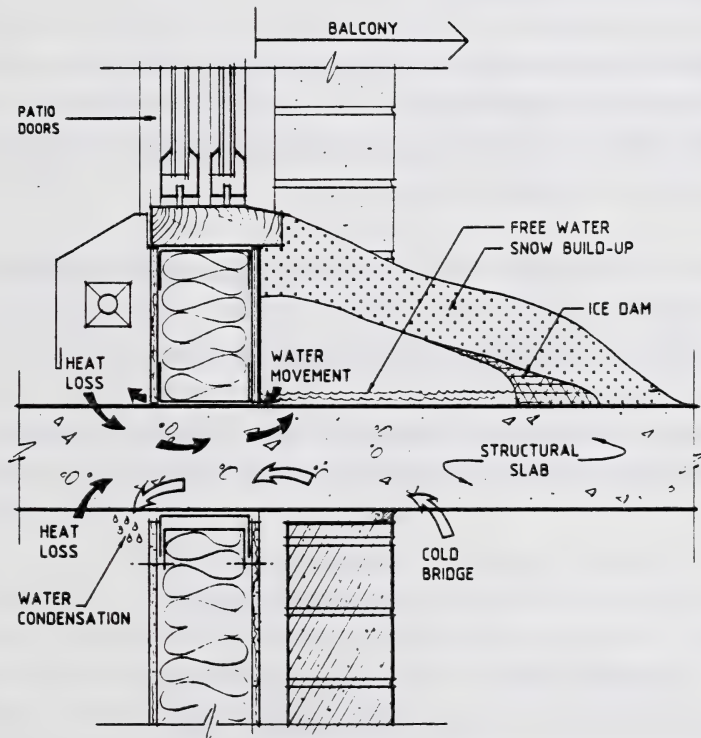
Balcony slab detail at Penetration of Envelope
Figure 12

Complaints of water infiltration at the base of the wall adjoining the balcony were more numerous than complaints about patio doors (see Figure 12).

Although there are only four instances where this problem is listed as serious in our survey table, there are many more that could be classed as inconveniences. This is an ongoing problem in building 28; thus when the developer decided to construct another identical building (#29), it was constructed with the balconies completely independent of the main structure. The second building has not experienced similar problems.
